## **SUMMARY**

There are forty-three (43) trees located on the east and south sides of the property. All the trees are recommended to be removed. This is due to their current size, condition, branch/root pruning required and the conflict with the new construction. There are no Protected Species.

I was asked by Kingsbarn Realty Capital to evaluate the trees along the east and southern property lines. The commercial property is located in Tustin, CA on the southeast corner of 17<sup>th</sup> St and Prospect Ave. It is planned to be developed with the current buildings to be removed and affordable housing created. These will be three-story buildings that will be built 10-12 ft. from the southern property line and 10-15 ft. from the eastern property line. The trees may be incorporated if they are in good condition and will not conflict with the new development.

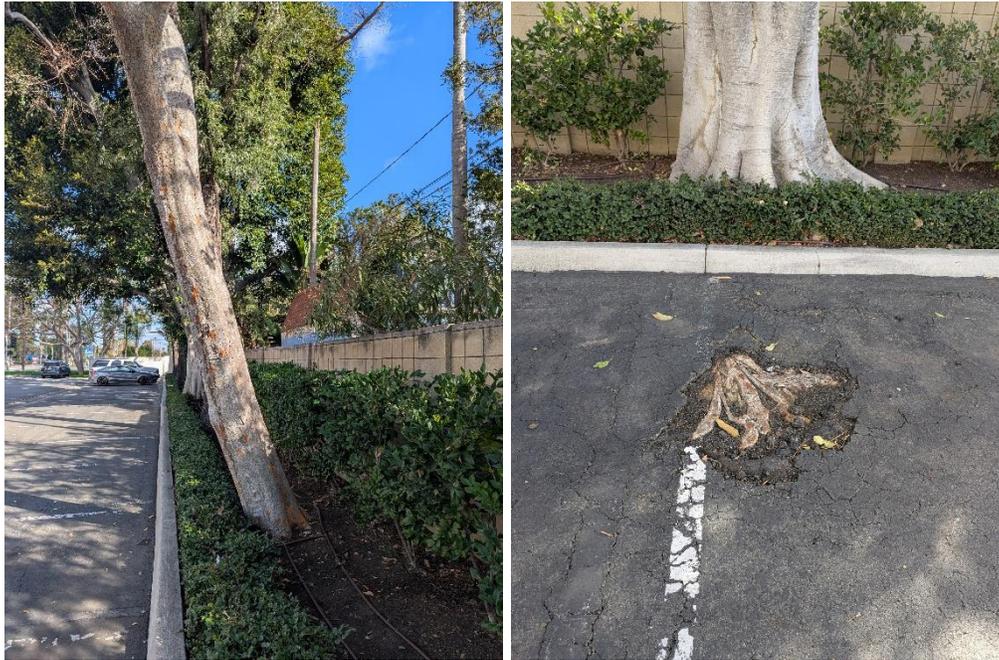
9, 10. Tree # 9 has root decay. Tree #12 has a leaning trunk.

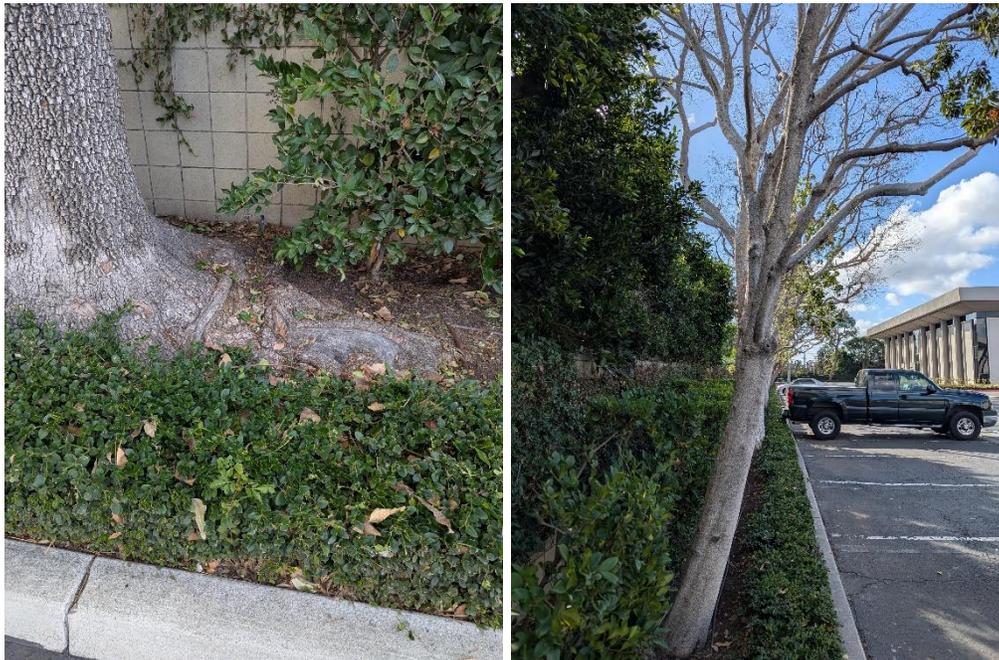
11, 12. Branches of Trees #13 & 15 that will need to be trimmed back. #15's co-dominant stem.

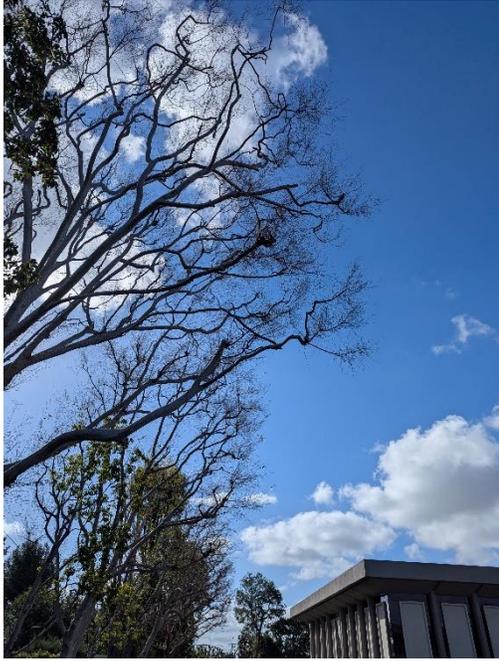
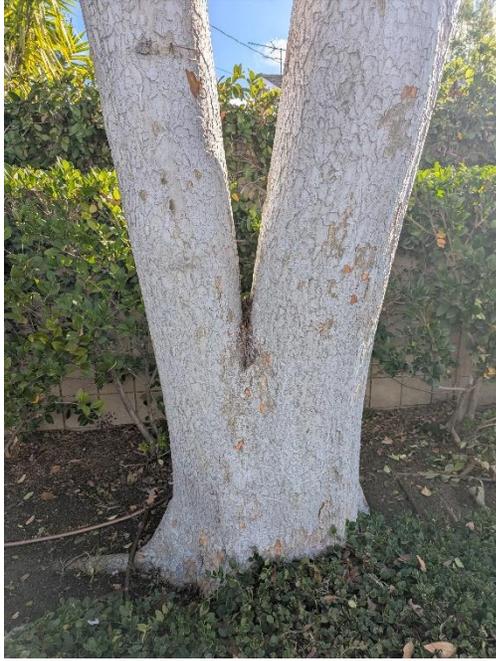
13, 14. Tree #16's trunk decay. Tree #17's co-dominant stems and included bark.

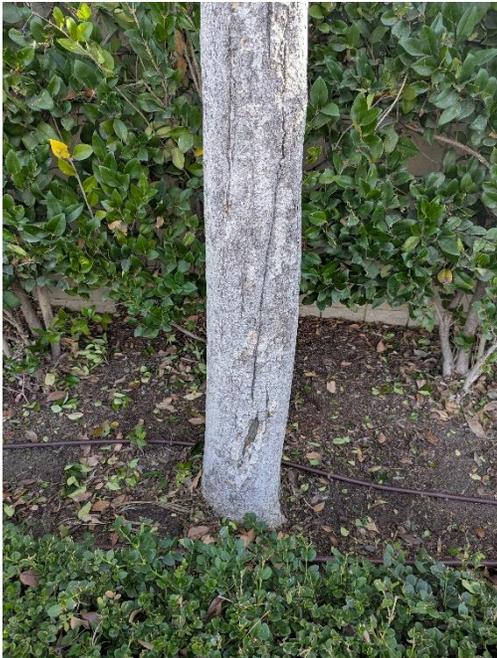
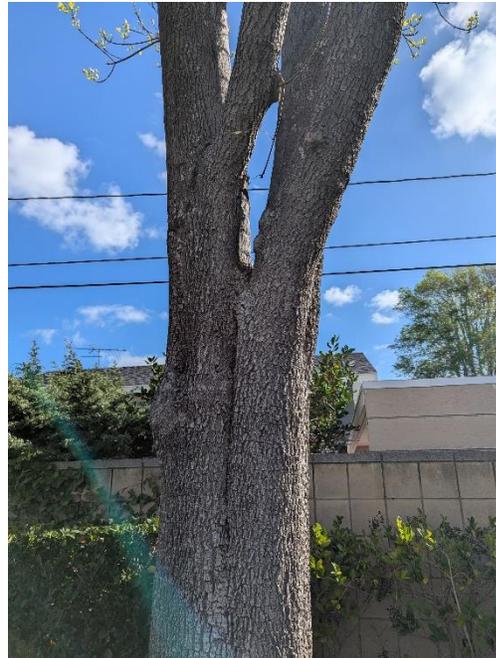
15, 16. Tree's #19 & 20 branches to be pruned back and leaning trunks.

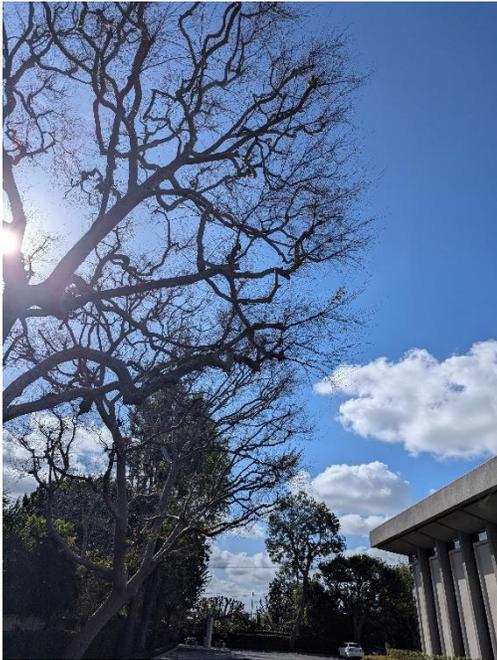
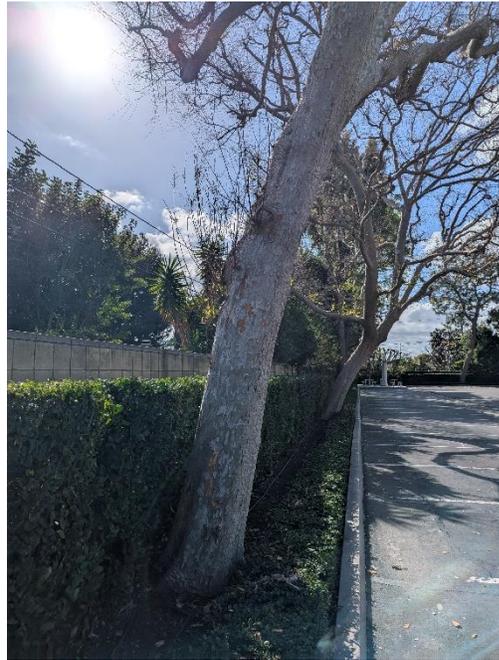
17, 18. Tree #22 co-dominant stem. Tree #23 over-pruned.

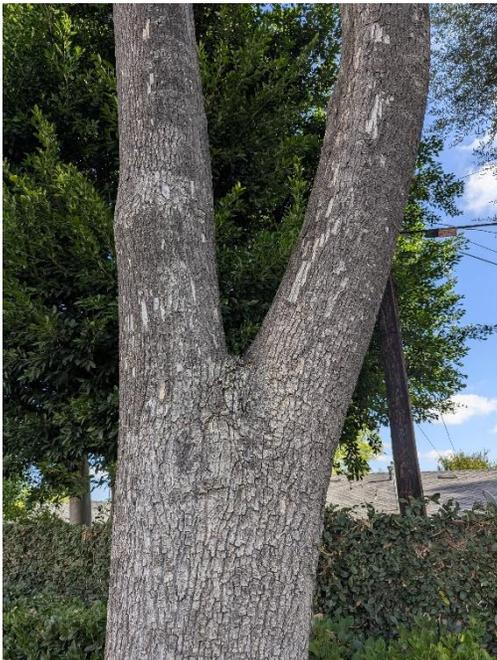
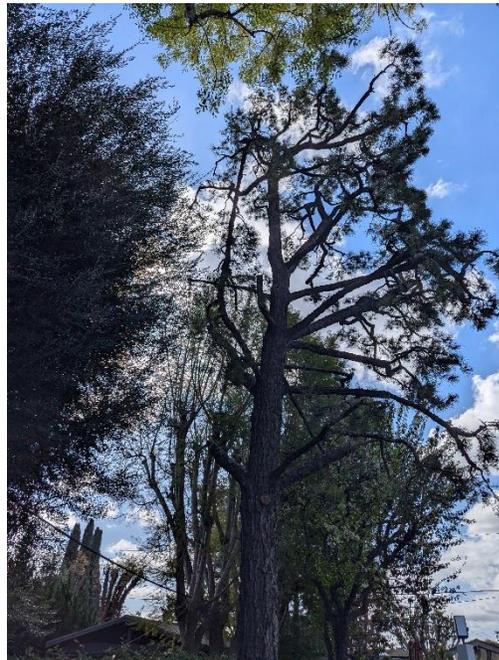
19. Tree #25 will need significant root pruning to facilitate construction.

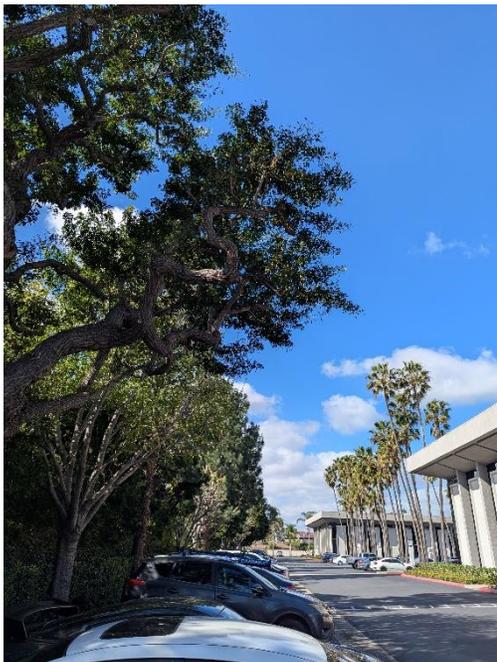
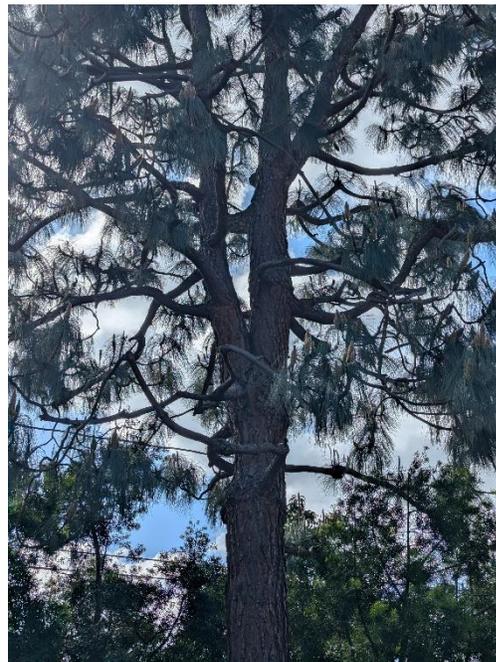
22, 23. Tree's #38 and 42 will need significant branch pruning to accommodate new construction.
