## **SUMMARY**

There are forty-three (43) trees located on the east and south sides of the property. All the trees are recommended to be removed. This is due to their current size, condition, branch/root pruning required and the conflict with the new construction. There are no Protected Species.

I was asked by Kingsbarn Realty Capital to evaluate the trees along the east and southern property lines. The commercial property is located in Tustin, CA on the southeast corner of 17<sup>th</sup> St and Prospect Ave. It is planned to be developed with the current buildings to be removed and affordable housing created. These will be three-story buildings that will be built 10-12 ft. from the southern property line and 10-15 ft. from the eastern property line. The trees may be incorporated if they are in good condition and will not conflict with the new development.

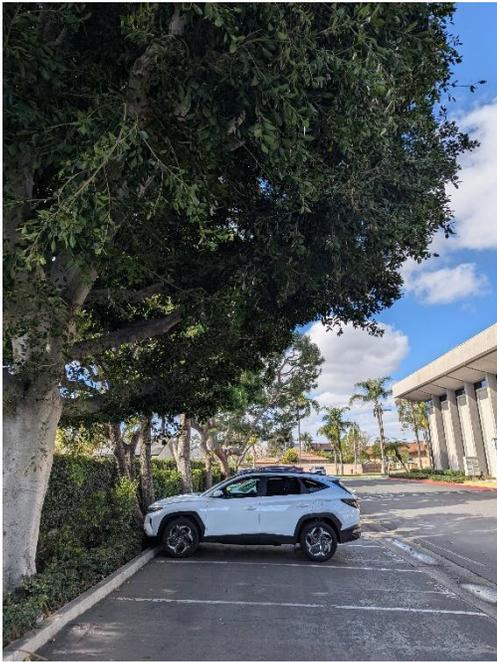
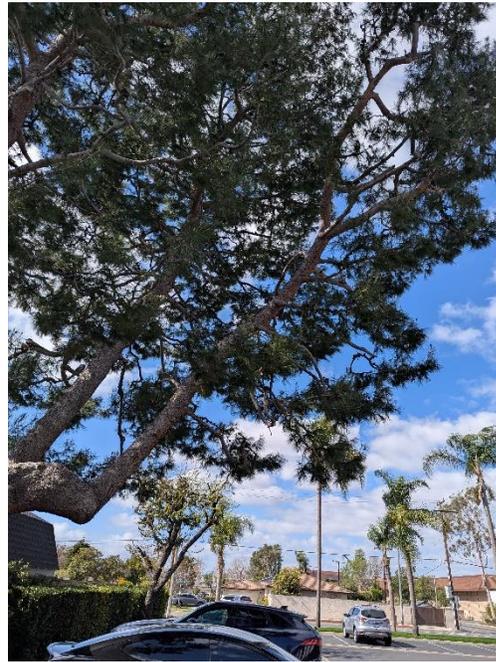
22, 23. Tree's #38 and 42 will need significant branch pruning to accommodate new construction.

I recommend that all the trees be removed. This is due to the conflict with the new development, the amount of branch and root pruning necessary, and the conditions of the trees. New trees, if desired, may be planted that will be more proper for the remaining space.
